# Appendix E

**ARBORIST REPORT  
AND  
TREE INVENTORY SUMMARY**

**Summer Villas at Sheldon  
9350 Sheldon Road  
Elk Grove, California, 95624  
APN 127-0010-077**

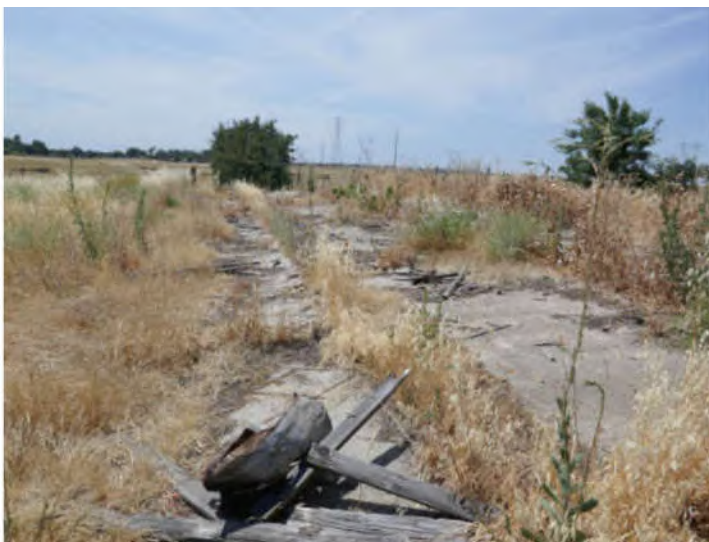
Photo #26:  
Concrete foundation  
remnants from former barn

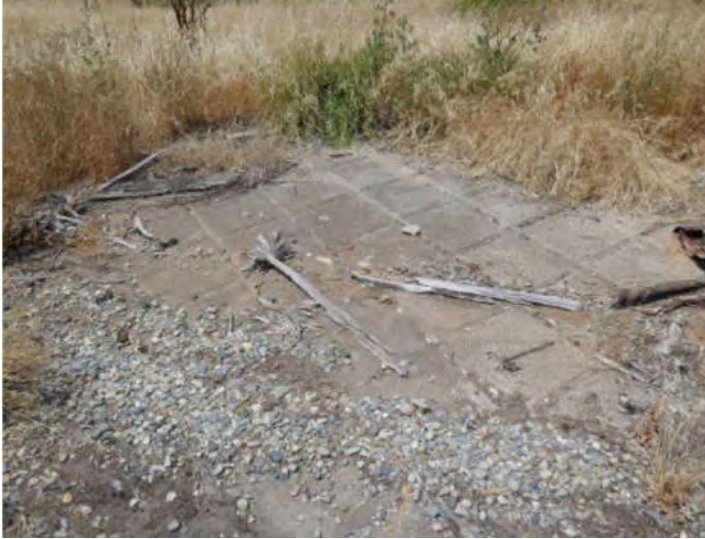
Photo #27:  
Concrete foundation  
remnants  
from former barn

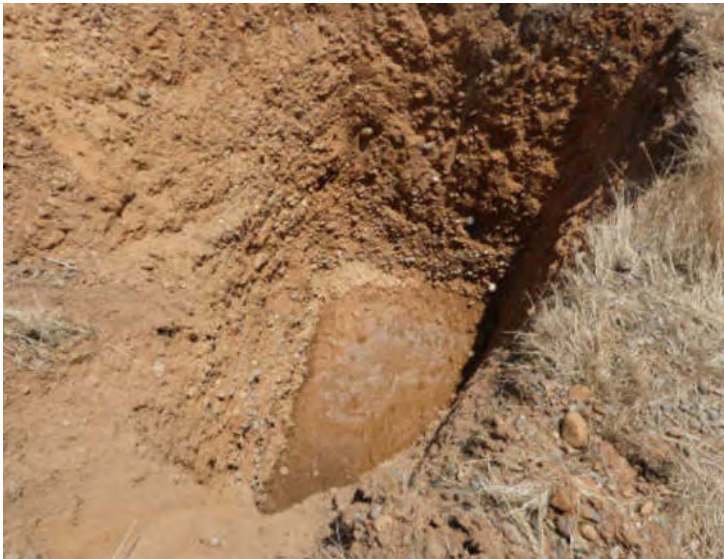
Photo #45:  
Moisture at the bottom of the  
excavation near dwelling
